Attributes of Porcelain Veneers:

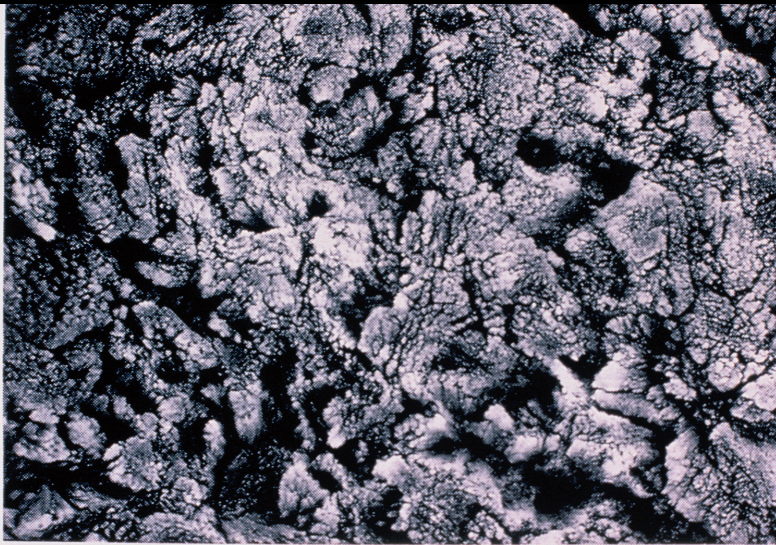
Figure 9. Unground enamel etched (15 s) with 32 per
H₃PO₄

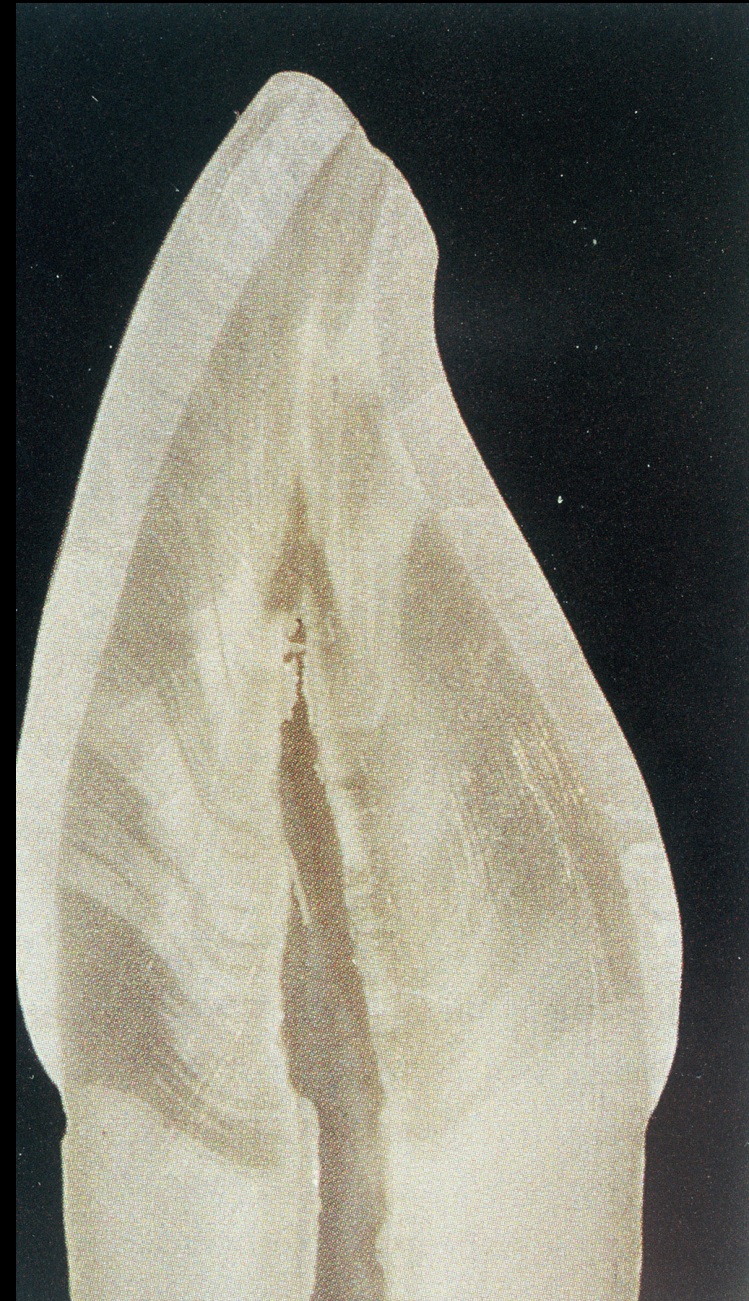
Ferrari, et al, 1992,
Int J Periodontics
Restorative Dent:

enamel of *anterior teeth* was:

1.0 – 2.1 mm at the incisal third

0.6 – 1.0 mm at the middle third

0.3 – 0.5 mm at the gingival third

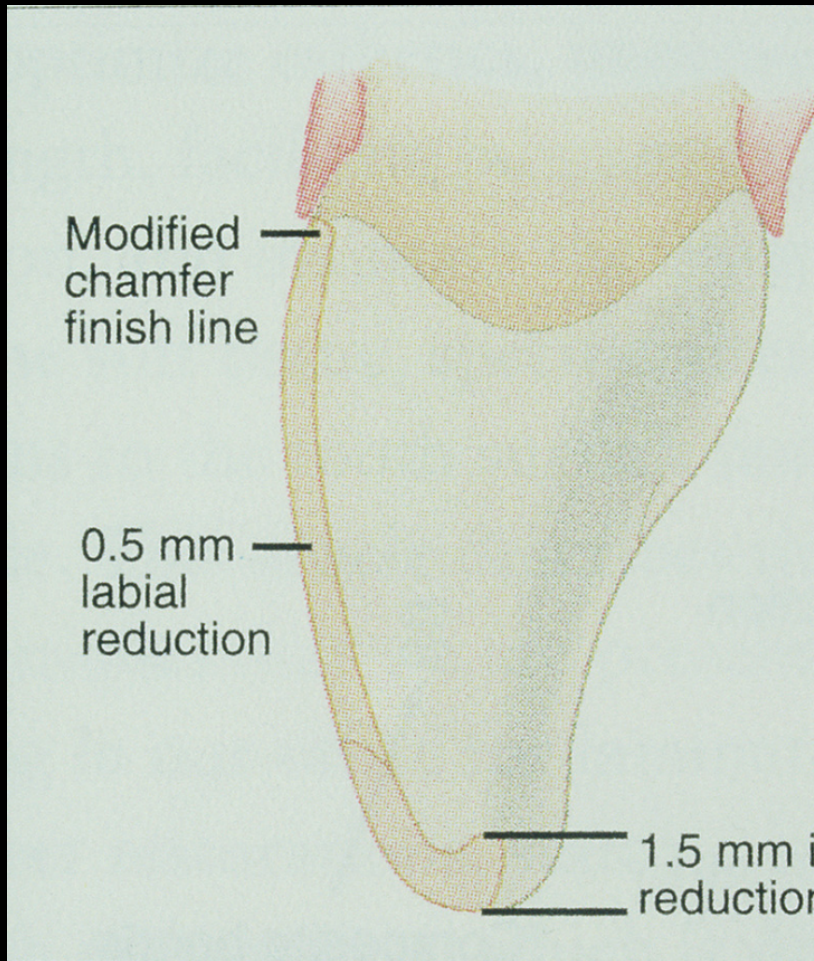
Diagram of sagittal section of an incisor prepared for a porcelain veneer.
